# LIVE LEAKS STOPPED AND SEALED WITH BELZONA

ID: 5982

Vertical sea water tanks in the activated carbon filtration plant of a coastal Hydrocarbon storage tank farm.

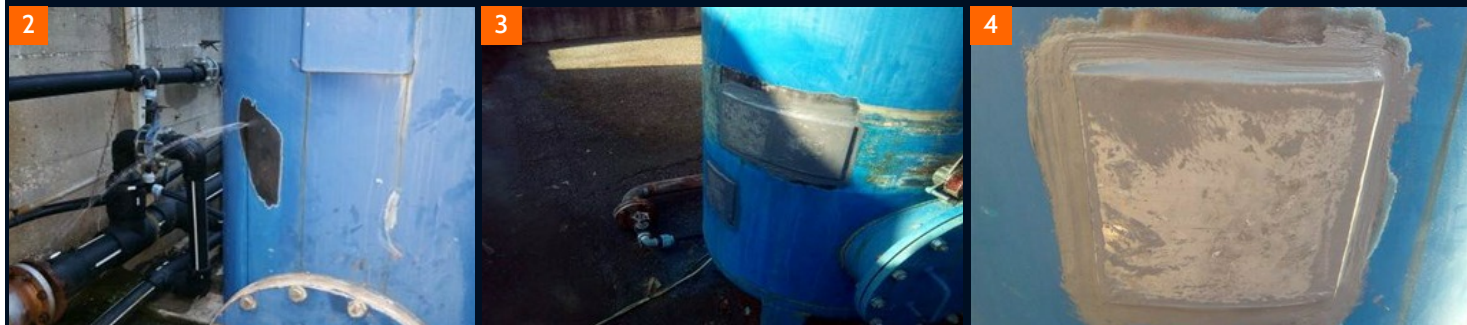
The tanks suffered from severe corrosion up to through-wall defects with some live seawater leakage. It was only possible to stop the filtration plant for two hours.

1. General view of equipment
2. Detailed leakage
3. Plate bonded with Belzona 1212
4. Close up of one of the bonded plates

The application was carried out in accordance with Belzona Know-How System Leaflet TCC-1. Surface preparation was carried out using an MBX bristle blaster. Several metal plates were cold bonded with Belzona 1212 to cover thin wall and through wall defects.

For a traditional weld repair, the customer would have to shut down the system and completely empty the tanks. Due to its surface-tolerant and fast-curing properties, Belzona 1212 was applied directly onto leaking tanks, bypassing the need for a shutdown. In a couple of hours the customer forgot about his problem.
