# BELZONA PROTECTS NEW PROCESS VESSELS FOR NATURAL GAS PURIFICATION PLANT

ID: 5985

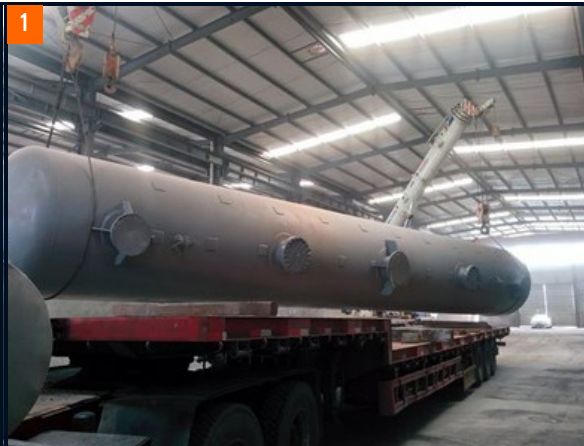
1. Overview of some vessels
2. Overview of interior of the vessels after blasting
3. Application completed and inspected
4. After 1 year in service, the re-inspection showed a "flawless" lining
