# BELZONA SEALS FLANGE ON VACUUM DRYER

A large diameter (approximately 2m) flange on vacuum drying vessel.

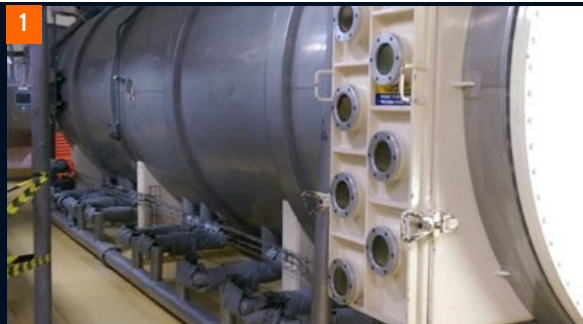
A leak around the flange had developed, preventing a vacuum to be accurately maintained within the vessel. This was affecting the drying process and production. A solution to seal this leak around the flange was required without dismantling the equipment. When the vessel is in operation it runs at elevated temperatures.

1. Vacuum vessel
2. 1st coat of Belzona 5851 applied with Belzona 9341
3. Application in progress
4. Completed flange seal
