# BELZONA REPAIRS DAMAGED FLOOR IN A WAREHOUSE

ID: 5987

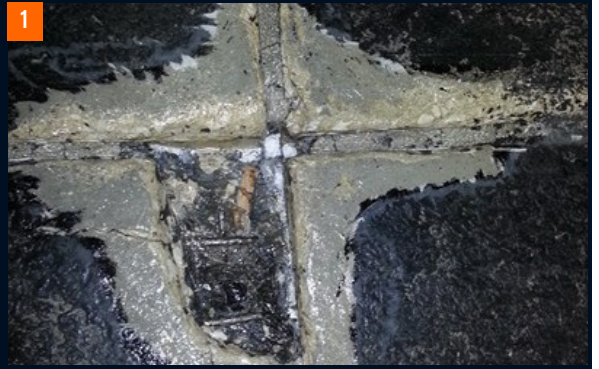
Concrete floor of a warehouse in a cement plant was damaged due to heavy traffic of forklifts and trucks, as well as storage of palettes with cement over time. The damage was situated on joint areas of large concrete plates (3m x 5m) of the floor.

1. View of application area
2. Application in progress
3. Application in progress
4. Situation after 8 years in service.

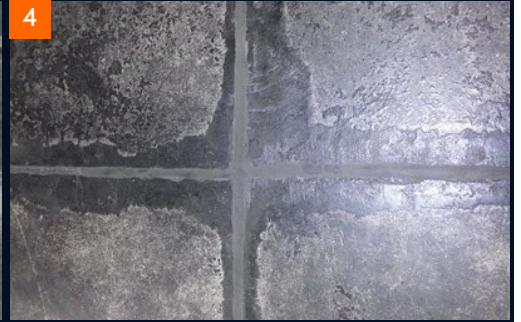
Because of continuous 24/7 production, the warehouse must be in use all the time and only small portion of it could be out of use. According to customer, Belzona offered the best value for money, allowing the customer's staff to do repairs themselves in periods with less activity in the warehouse. Site revisited after 1 year shows that repaired area is still in perfect shape.
