# BELZONA WITHSTANDS PROLONGED WET ABRASION

Sludge immersion pump at a paper mill operating under severe wet abrasion conditions.

Paper Mill, Turin, Italy

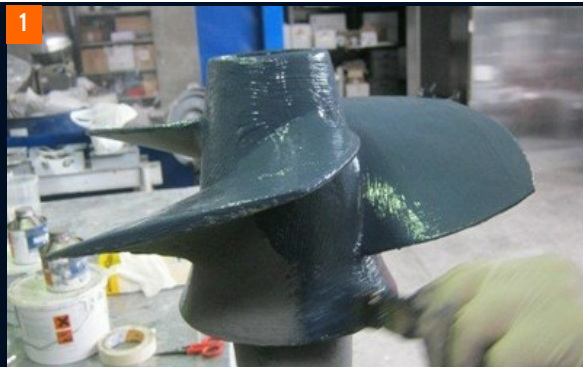
1. Pump impeller being coated
2. Pump lining applied
3. External coating applied
4. Inspection after 4 years in service

The application was carried out in accordance with Belzona Know-How System Leaflets CEP-3, CEP-4 and CEP-5. Surface preparation was carried out using grit blasting. Pitted and eroded areas were rebuilt with Belzona 1311, the internal surfaces were then coated with Belzona 1321 to protect the pump from erosion-corrosion. Belzona 5811 was then used to protect the external surfaces of the pump.

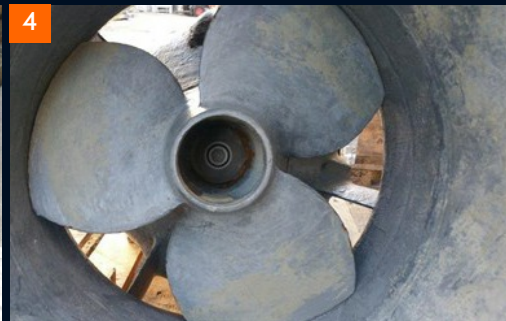
The Belzona solution successfully withstood wet abrasion and managed to significantly prolong the life of this pump. After 4 years in service, the pump was inspected and found to be in perfect condition, with the Belzona coatings predominantly intact. These 4 years of stress-free operation amounted to significant savings due to the absence of maintenance and downtime. The length of maintenance-free time has now been doubled and instead of scrapping the whole pump, customer only needs to replace the coating.
