# BELZONA REFORMS SEAL FACES IN SHIPS CYLINDER BLOCK

ID: 5992

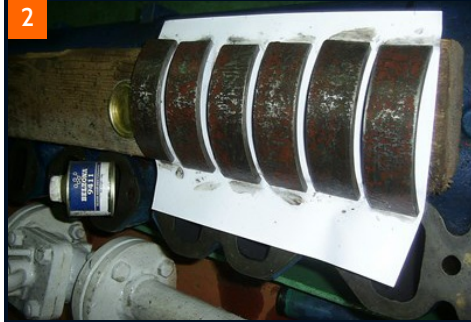
Erosion and corrosion had damaged the seal faces. Conventional repairs were not an option.

1. Preparation of one defect completed
2. Forming plates coated with Belzona 9411
3. Application of Belzona 1111 in progress
4. Completed application

The application was carried out in accordance with Belzona Know-How System Leaflet ENC-5. After preparing the damaged areas, carefully profiled formers coated with Belzona 9411 were used to reform Belzona 1111 to the required seal face dimensions. Once cured, the formers were removed and excess Belzona was trimmed away to leave the accurately formed seal faces.
