# BELZONA "SMOOTH RIDE" APPLICATION OF EXPANSION JOINTS SAVES BOTTLES

ID: 5998

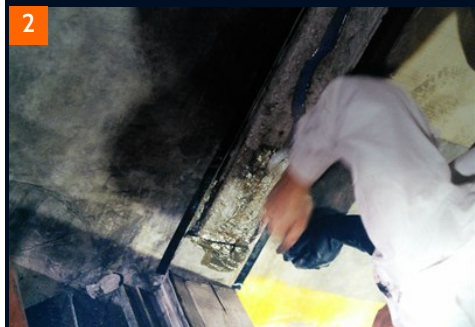
The warehouse floor suffered from uneven surfaces and bumps, causing product spills and long man hours to ensure cleanliness and safety.

1. Concrete below grade at old doorway.
2. Applying Belzona 4911 after surface preparation.
3. Belzona 4111 trowelled smoothly over the defect areas.
4. Repair holding up to forklift traffic years later.
