# O-RING FIT RESTORED WITH BELZONA

Eroded O-Ring fit.

Air compressor cooler waterbox.

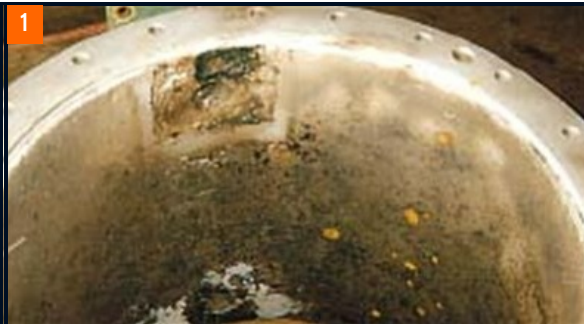
1. Corrosion and eroded o-ring fit.
2. A new O-Ring was used to form the fit.
3. Entire waterbox was coated.
4. O-Ring fit restored and back online.
