# BELZONA CHILLER PROTECTION

ID: 600

Chiller unit from the hotel air conditioning plant

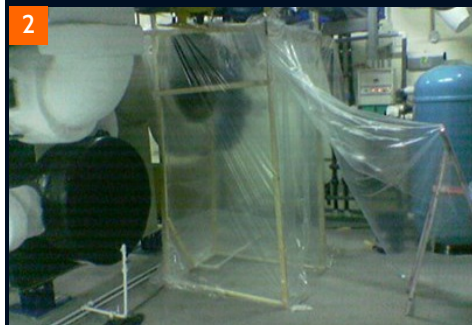
Corrosion of the tube sheet and water box.

1. The corroded water box
2. Surface preparation
3. Tube sheet completed
4. Water box completed

Application was carried out in accordance with Belzona Know-How System Leaflet HEX-3.
