# BELZONA ENSURES SAFETY ON WASTE MANAGEMENT TRUCKS

ID: 6000

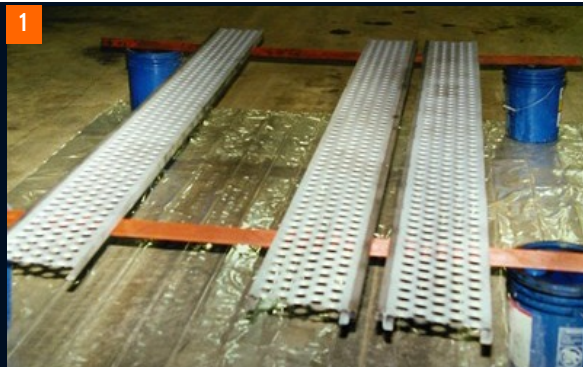
1. Surface preparation on full length stair treads
2. Non-Slip application completed on stair treads
3. Close up of an aggressive texture of the application
4. Steps installed on one of the garbage trucks

Because of the excellent adhesion of Belzona 1321, it was the right material to hold Belzona 9211 in place. The product is also durable enough to withstand the cleaning of the steps in winter when snow and ice accumulated. The application to bulk stair treads allowed for cutting and installing as needed without reapplication. The dependability of this non-slip surface saved the workers from personal injuries as well as the company from loss time and incidents.

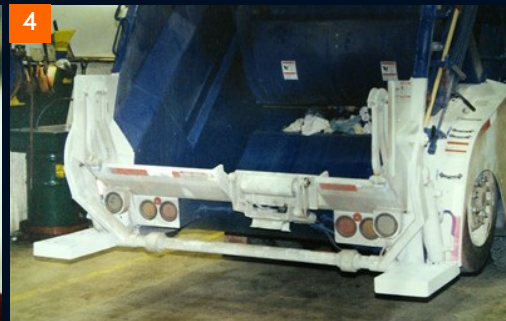
Workers rode on the back of moving trucks in adverse conditions which caused slippery footing. Safety was a big concern for these employees and, unfortunately, the factory installed steps were not sufficient. With more trucks to be put in service the solution needed to be replicated.
