# DUST COLLECTION BAG HOUSE PRESERVED WITH BELZONA

ID: 6001

Square to round transition on a dust collection bag house at a particle board manufacturing plant.

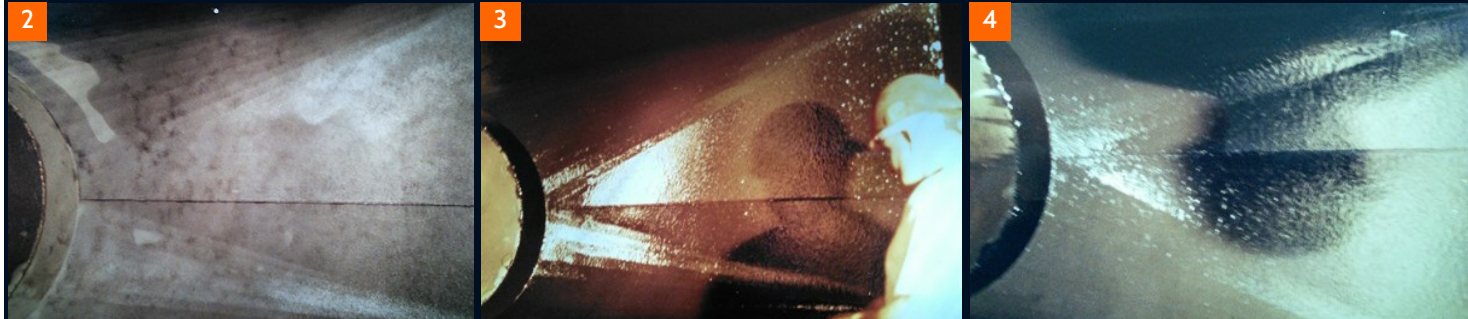
Unprotected steel was exposed to moisture repeatedly at this transition piece of duct work. The moisture enabled corrosion that began destroying this section of duct work. Undetermined repair or replacement times were not a good option for this particle board manufacturer. Due to the critical production need of this equipment and to the elevated location of the transition piece it was important to preserve it from failing.

1. Surface profile prepared
2. Belzona 9111 applied
3. First coat of Belzona 5811 applied
4. Second coat of Belzona 5811 complete

The application was carried out in accordance with a modified version of Belzona Know-How System Leaflet TCC-5 and Belzona Instructions For Use.
