# RUDDER PINTLE REBUILT WITH BELZONA 1111

ID: 6004

Rudder pintle shaft on a 700' US Navy ship.

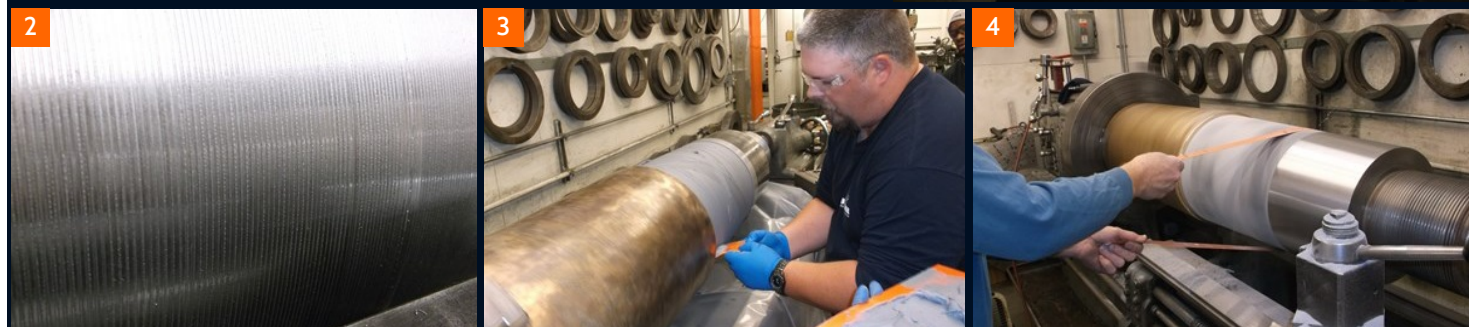
## PHOTOS

Shaft was corroded and pitted from salt water.

1. Shaft already machined down, some damage still visible.
2. Rough cut thread pattern.
3. Applying Belzona 1111.
4. Completed application, finishing with emery cloth.

All of the damaged areas were removed with a lathe. The surface was then prepared with the lathe to leave a super rough thread pattern to ensure a full mechanical bond. Again, using the lathe, Belzona 1111 was applied with a slow rotation. After a sufficient amount of material was applied, Belzona 1111 was allowed to fully cure and then machined to the required specifications. There was one low spot and a couple of air pockets visible, so those areas were once again abraded and a further layer of Belzona 1111 was applied and allowed to cure before the final machine cut was made. The final finish was made using emery cloth, leaving a perfect smooth finish.
