# BELZONA REPAIRS PRESS PLATEN AND SAVES REVENUE LOSSES

ID: 6005

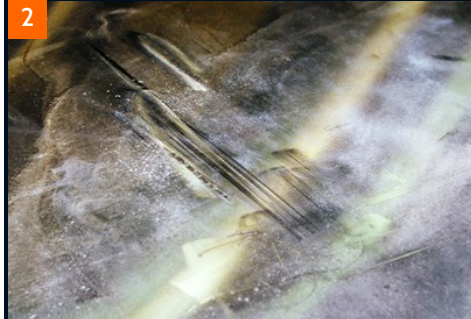
Damaged platen on the press of this particle board manufacturer was causing culled product. Particle board quality was not meeting standards due to the damage of the platen surface. The surface needs to be flat and smooth and the repair material must be machinable and withstand high temperatures of the steam heated platen. Quality control of this particle board manufacturer is very high and would not allow the defects that the damaged platen produced. All the effort and costs of process up to the point of the press in this manufacturing process was wasted when this platen was used. The wall thickness of the steam platen would deform if arc welding was performed to repair the damage.

1. Damaged steam platen surface
2. Surface of platen prepared
3. Belzona 1111 applied and curing
4. Smooth surface of platen restored
