# UNIVERSITY PLANTER SEALED WITH BELZONA 3111

ID: 6006

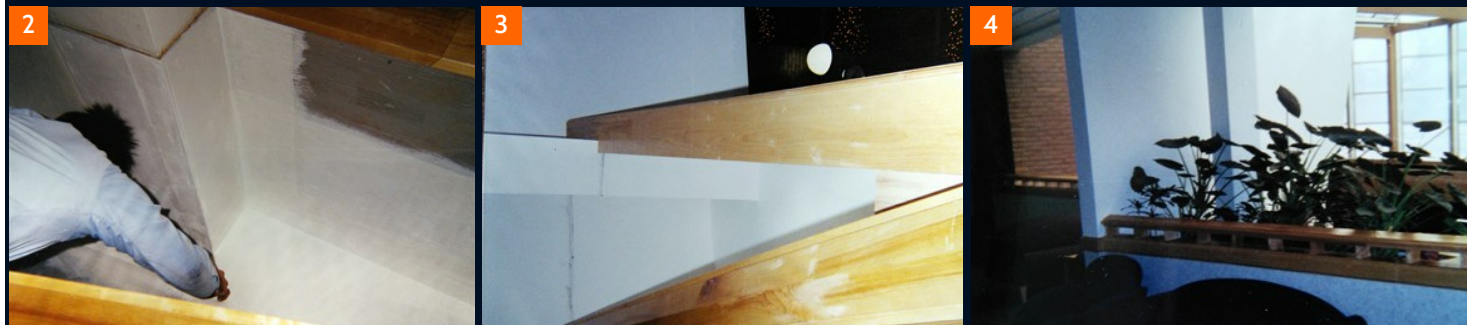
## PHOTOS

Planter was lined with a rolled roofing membrane that was not conducive to the irregular shape of the planter. When planter was filled with planting media the seams would separate and leak. The rolled roofing application was attempted a number of times and continued to leak.

1. Planter box coated with Belzona 3921
2. Belzona 3111 being applied
3. Planter box fully coated
4. Planter box in use after the repair

Customer had spent much time and effort trying to make rolled roofing product work. Belzona 3111 was easier to apply on this irregular shape. The sealing of this planter allowed the highly visible area to maintain aesthetics with use of this planter and prevented water damage and slip hazards on the floor below, saving great expense. Planter box still in use over a decade later.
