# BLENDER LINER AT PARTICLE BOARD MANUFACTURER RESTORED WITH BELZONA

ID: 6007

Liner of the blender used to mix wooden particles.

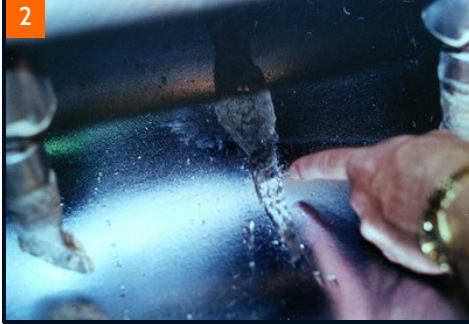
Wood particles being mixed with resins in this blender caused a very abrasive condition. Even though the liner to this equipment was designed to withstand abrasion it still suffered the effects. Particle board manufacturer was in the habit of welding new liners into this equipment when they wore out. The liner replacements were expensive and time consuming having to remove the worn liner and weld in the new one. This required extensive hot work in a wood laden environment and would typically warp the equipment causing misalignment of the lid.

1. Blender liner showing damage caused by erosion
2. Surface preparation completed
3. Belzona 1311 applied to the worn areas
4. Completed application with Belzona 1321
