# LARGE EXPANSION JOINT SEALED WITH BELZONA

ID: 6008

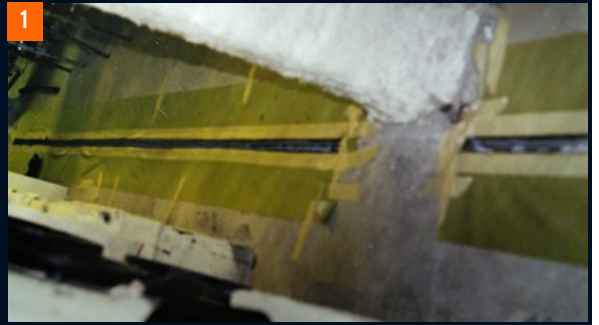
Gap in the expansion joint allowed room pressure to escape room below into this area, causing Air Handler performance to be inefficient. The gap was so large that wheels from equipment carts would get stuck in the crack, becoming a safety concern.

1. Floor preparation
2. Applying Belzona 2911
3. Installing backer rod
4. Removing masking tape prior to cure

The application was carried out in accordance with Belzona Know-How System Leaflet FPA-6 and Belzona product Instructions For Use.
