# BELZONA PROTECTS HOG FUEL SCREW CONVEYOR

ID: 6009

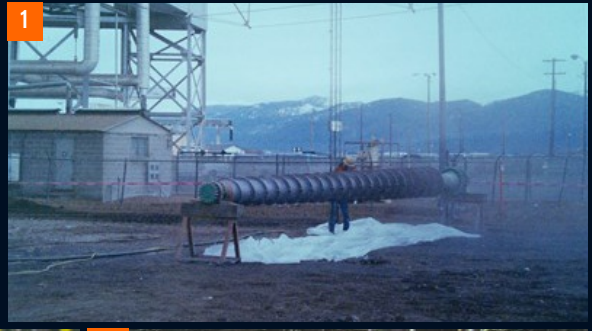
1. Grit Blasting of auger
2. Belzona 1812 applied to base of flighting
3. Shipping wrap placed over Belzona 1812 to smooth surface
4. Full length of auger protected and improved
