# INDUSTRIAL WASTEWATER IMPELLERS REPAIR

ID: 601

Wastewater impellers (three)

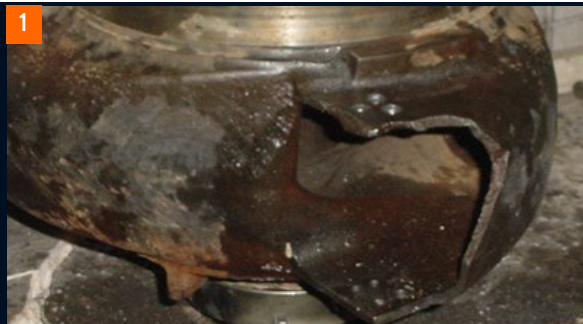
The edges of impellers were broken due to impact, abrasion and corrosion.

1. The broken edges of the impellers
2. Steel sheets inserted to form the leading edges
3. Edges were formed by Belzona 2111
4. Final application, coated by Belzona 2121
