# MORE THAN 500 FLANGES ENCAPSULATED WITH BELZONA

ID: 6011

Flange connections on a gas distribution station

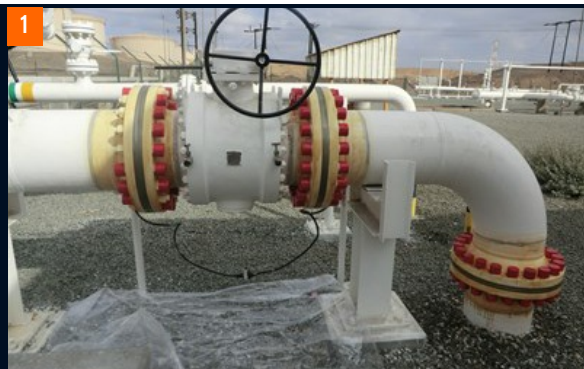
1. Substrate ready for application with bolt covers, bridging tape and application of Belzona 8411
2. Application of base coat of Belzona 3411
3. Application completed with second coat of Belzona 3411
4. Completed applications on several flanges

Heavy rain in the region and galvanic corrosion on the flanges caused severe corrosion and unsafe operation. Previous protection was a spray applied system and after inspection of the flanges, the customer was required at an additional cost to mobilise the specialist application team in order to reinstall the system.

The application was carried out in accordance with Belzona Know-How System Leaflet GSS-11.
