# BELZONA PLATE BONDING SOLUTION SEALS STEEL PLANT GAS LEAKS

ID: 6012

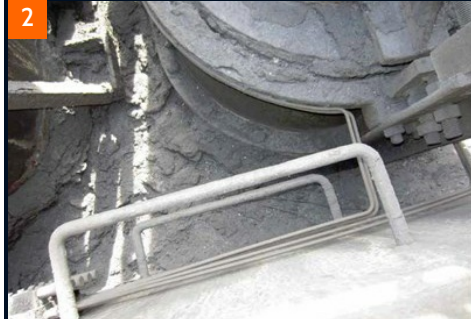
1. View of steel plant furnaces with corrosion problems
2. Heavily corroded base underneath the debris
3. Applying Belzona 1251 to prepared area
4. Completed application after coating with Belzona 5851

The application was carried out in accordance with Belzona Know-How System Leaflet VPF-11. After cleaning and grit blasting the leaking areas, custom designed plates were bonded into place with Belzona 1251, Belzona 5851 was then coated over the top for further protection.
