# FLEXIBLE PROTECTION FOR ACID BUND WITH BELZONA

ID: 6014

Chemical Bund around 93% Sulfuric Acid Tank

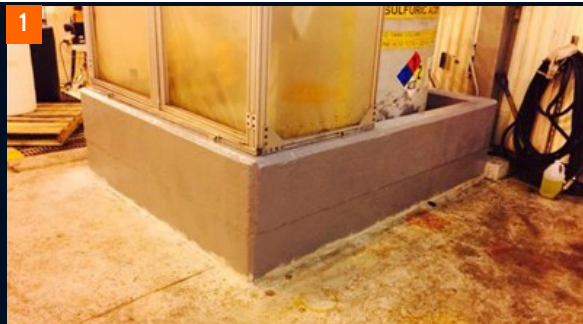
The bund in place to contain spillages from a 93% sulfuric acid tank experienced splashes and spills, resulting in the failure of existing protection. In addition, structural movement resulted in small gaps forming between the floor and bottom of the wall inside the containment area.

1. Chemical Bund containing 93% Sulfuric Acid Tank
2. Belzona 4361 applied in two coats
3. Completed application
