# BELZONA STATIC DISSIPATIVE SOLUTION APPLIED TO SILO

ID: 6017

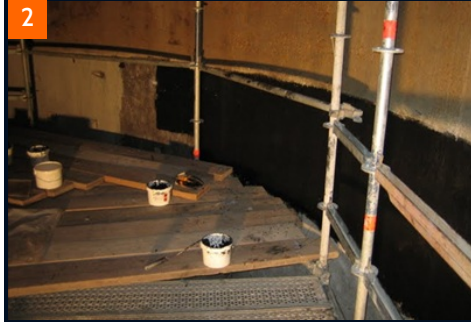
1. Earthing points left exposed in restored silo wall
2. Section of silo coated in Belzona 4351
3. Silo cone repaired and left with earthing points
4. Silo cone coated with Belzona 4351

Application was carried out in accordance with Belzona Know-How System Leaflets TCC-3. Damaged concrete was repaired with Belzona 4111. Belzona 4351 was applied to walls and cone taking care to ensure Belzona 4351 was in direct contact with the earthing points provided.
