# BELZONA 5811 INJECTION PREVENTS NOZZLE CORROSION

ID: 6021

40 inch gas transfer pipeline 2", 3" and 4" nozzles.

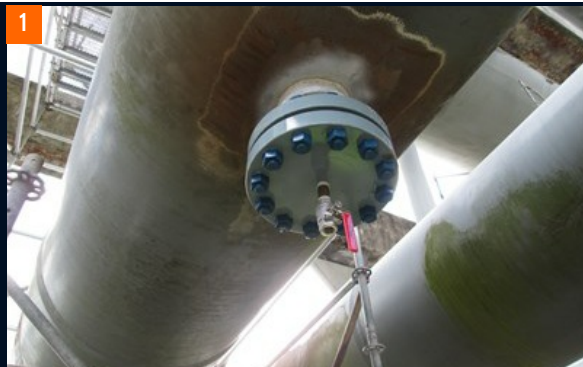
1. Encapsulation nozzle with blind flange bolted on.
2. Cut off old nozzle encapsulated by new nozzle.
3. Belzona 1121 used to fill void prior to injection.
4. Belzona 5811 injection in progress.

Old corroded nozzles were cut off and new encapsulation nozzles of a larger diameter were welded on around the stub from the old cut-off nozzle. Belzona 1121 was used to fill in the void between the old stub and the new encapsulation wall (where an air pocket would have formed). A blind flange tapped for a 3/4 inch hose was then secured to the new encapsulation nozzle. The blind flange had a 3/4 inch hose and ball valve which was connected to a paint pot. The correct calculated volume of Belzona 5811 was then mixed and set into the paint pot, and air pressure was applied to inject the Belzona 5811 into the encapsulation nozzle. The hose was quickly swapped out for a threaded plug, and the whole encapsulation was wrapped in heat trace elements. After a one hour set up at ambient temperature, the encapsulation was brought to 175°F over a 4 hour period, and then held for two hours to ensure full mechanical cure.
