# BELZONA ELIMINATES MATING SURFACE CORROSION

ID: 6031

Garage cover on a passenger ship needed attention.

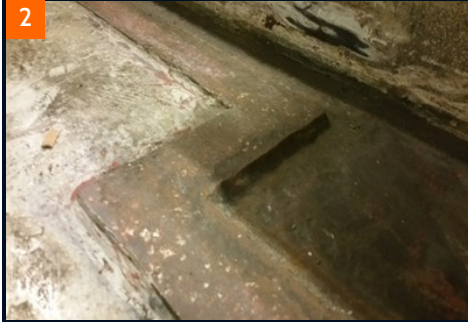
Severe corrosion of the mating surfaces led to the loss of metal. As a result, the gasket between the floor and the cover didn't work properly.

1. General view of the garage
2. Damaged sealing area
3. Belzona 1161 used to rebuild the damaged area
4. Repair overcoated with Belzona 5831 for corrosion protection

The application was carried out in accordance with Belzona Know-How System Leaflet GSS-8. Surface preparation was carried out by grinding. The pitted and eroded areas were rebuilt using Belzona 1161. The plates were then protected with a coat of Belzona 5831.
