# SEAWATER FIRE PUMP REPAIR WITH BELZONA

ID: 6033

Fire pump using sea water

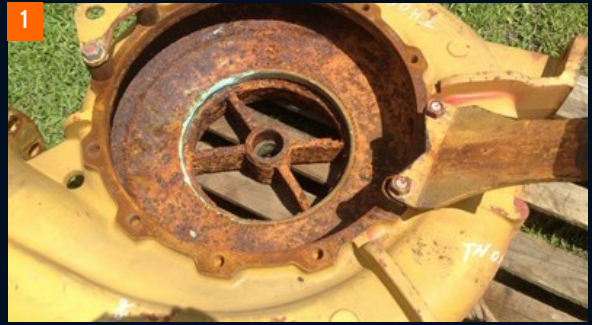
The customer was having problems with severe corrosion on the pumps due to them being idle for months at a time, often after only a few years of use they were being replaced with new ones.

1. Severely corroded pump
2. Corroded pump end-cover
3. Pump after the application
4. Pump end-cover after the application

The application was carried out in accordance with a modified version of Belzona Know-How System Leaflet CEP-3.

Belzona 1111 (Super Metal)  
Belzona 1341 (Supermetalgilde)
