# UNDETECTABLE MOISTURE BARRIER FOR MUSEUM PROVIDED WITH BELZONA

ID: 6035

Historic Museum, Teesside, UK

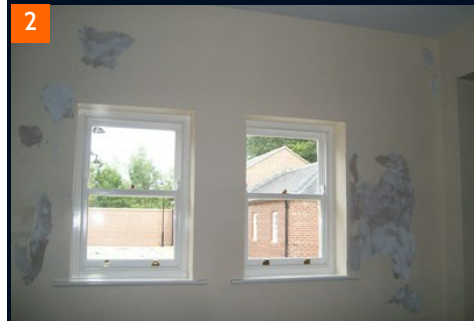
On the external walls of the East Lodge building, it was found that moisture ingress from driving rain quickly destroyed the newly refurbished rooms, wasting a large portion of the budget. A cost effective weather proofing solution that would not affect the appearance of the buildings was required.

1. Museum situated within Historic Estate
2. Damage to paint and plasterwork in classroom
3. Original application completed in 2010
4. East Lodge revisited in 2016

Belzona 5122 offers an invisible water repellent barrier that allows the surfaces to breathe and improves the thermal performance of saturated walls by up to 40%. Approximately 270 square meters of the external walls were quickly treated with a simple application that minimised disruption to the museum visitors. The surface was immediately weatherproof and undetectable to the naked eye. The client was delighted with the results and the refurbishment to the rooms within could resume without further risk. The protection of the building was reassessed 6 years later and found to still be working perfectly.
