# BELZONA SAVES THE ALIGNMENT OF THE PUMP AND MOTOR

ID: 6038

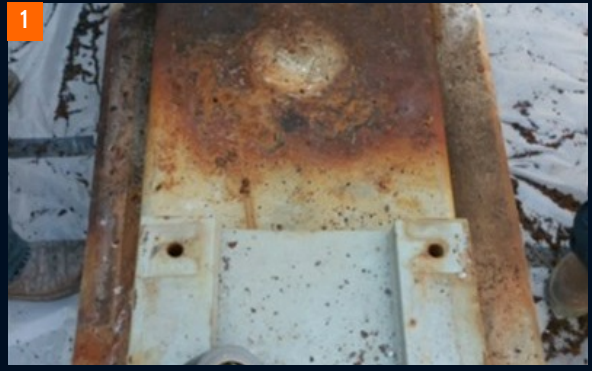
The occasional leaking seal of process water was causing the advanced corrosion attack of the metal substrate of the pump base, which was leading up to the possibility of the base collapsing. At which point the pump and motor would be out of alignment.

1. Corroded pump base
2. Pump base blasted and Belzona 1121 being applied
3. Belzona 5811 applied to pump base
4. Belzona 5233 applied as a top coat.

1. Pumps were removed for access to the pump base. 2. Substrate was blasted clean to near white finish. 3. Belzona 1121 was applied to all pits and welds as per the IFU. 4. Belzona 5811 was applied to the entire pump base as per the IFU. 5. Belzona 5233 was applied to the entire pump base for further UV protection.
