# OIL COOLERS PROTECTED WITH BELZONA

ID: 6039

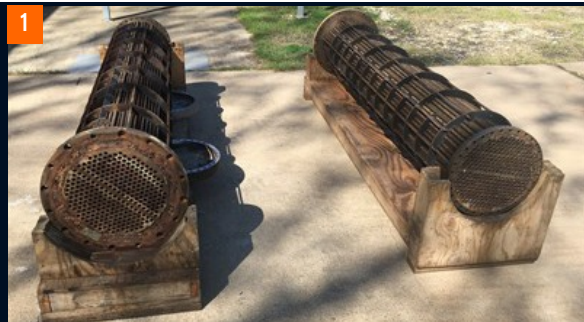
The customer was getting cross contamination between process cooling water and process lubricating oil, due to the corrosion at the copper tube and carbon steel tube sheet interface.

The tube sheets and end covers of heat exchangers used for oil cooling were suffering from corrosion.

1. Chillers derived with pitting on tube sheet face.
2. Picture of end covers with pitting.
3. Finished end covers with final coat of Belzona 1321.
4. Repaired tube sheets with Belzona 1121 and Belzona 1321.

The application was carried out in accordance with Belzona Know-How System Leaflet HEX-1. First, all of the tubes were corked. Then the surface of tube sheets and end covers were blasted. The tube sheet was then rebuilt flush and the pitting on end covers were filled in with Belzona 1121. All surfaces were coated with 2 coats of Belzona 1121 as per IFU.
