# BELZONA RESCUES A PIPELINE AT THE CRUNCH TIME

ID: 6040

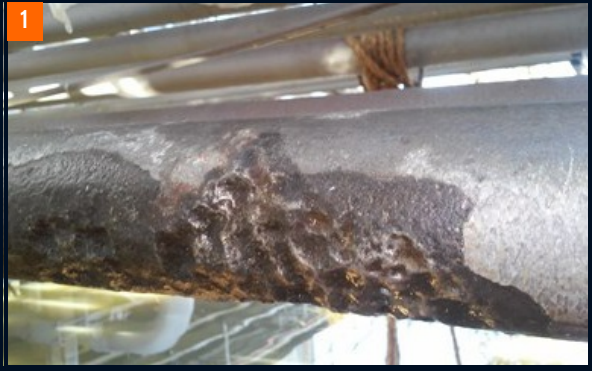
Customer had two ethyl glycol lines needing repair. The pipes were located near the waterline and access was difficult. One pipe had several through-wall defective areas whereas the other had thin-wall defects.

1. Original condition. Significant exterior corrosion causing wall loss.
2. After abrasive blasting shows several holes.
3. Post curing composite wrap with heat tape.
4. Completed application.

Belzona 1511 was used to fill pits and rebuild the wall thickness lost. 5 layers of Belzona 9381 wetted with Belzona 4981 were applied with 50% overlap. Belzona 9382 was used to consolidate the repair. The system was allowed to cure at ambient temperature for 24 hours, then post cured at 200°F for 6 hours.
