# BELZONA STOPS LEAKS AND PROTECTS PARKED CARS

ID: 6043

Cooling tower drain lines.

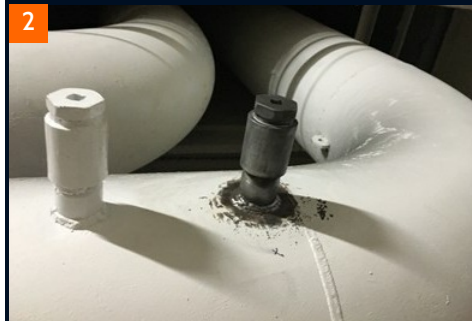
1. Before Application
2. After surface preparation
3. Belzona 1161 used to apply cap to leaking area
4. Complete project with Belzona 5111 used to match the existing paint on the line
