# BELZONA REPAIRS AND SAVES INTERNALS OF WASTEWATER PIPE

ID: 6045

42" Ductile Iron underground pipe.

Water Treatment Plant, Bossier City, LA, USA

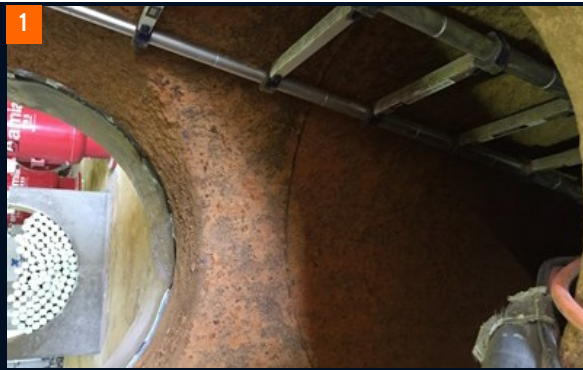
The pipe was corroded so badly that the pitting was causing pin holes in the substrate.

1. Corroded pipe before application.
2. Internals of pipe after SP-10 Abrasive Blast.
3. Applicators applying Belzona 1121 to pitting.
4. The pipe after being coated with Belzona 5811.
