# BELZONA REPAIRS BEAM ABOVE PAPER MACHINE

ID: 6046

Support beam above paper machine.

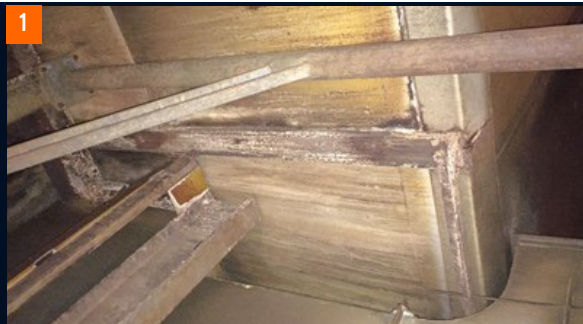
Badly corroded beam that was rusted completely through. The vibration of the paper machine was causing rust to fall on the paper sheet and break the paper causing the machine to shut down several times a day.

1. Corroded beam
2. Beam after SP-10 blast
3. Beam after rebuild and coating
4. Beam after coating
