# BELZONA REBUILDS CLARIFIER RUNNING TRACK

ID: 605

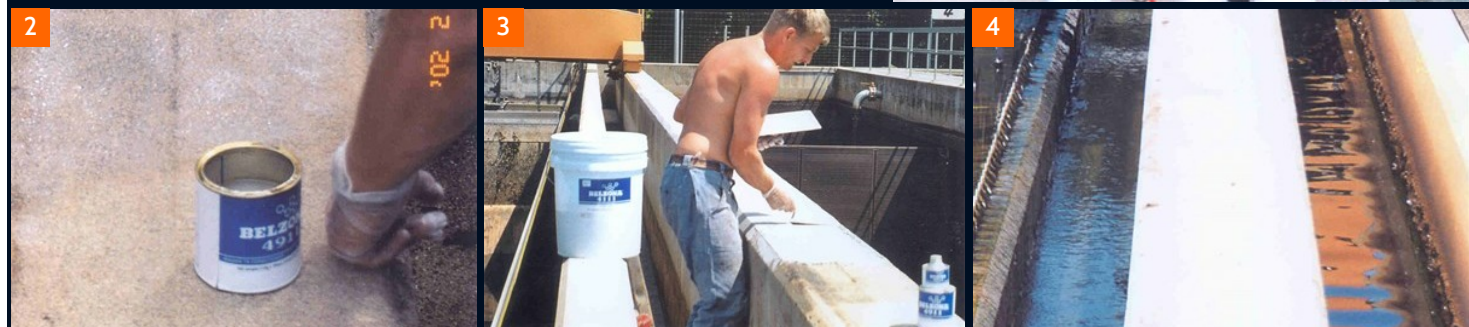
## PHOTOS

The wheels had caused between 2mm and 10mm wear to the concrete and were not running smoothly.

1. The clarifier track
2. Conditioning the surface with Belzona 4911
3. Rebuilding with Belzona 4111
4. The finished track

The track was rebuilt with Belzona® 4111 in accordance with Belzona Know-How System Leaflet FPA-1.
