# BELZONA REPAIRS REFINERY BOILER ROOM ROOF

ID: 6053

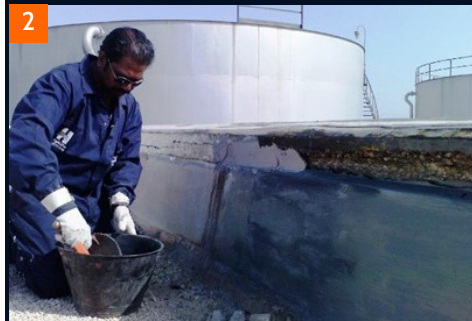
Spalled concrete on the parapet side of the roof allowed water ingress that resulted in flooding inside the Boiler Room.

1. View of damaged parapet wall 2.  
Concrete repair using Belzona 4111 3.  
View of completed application including  
Belzona 3111 waterproofing protection 4.  
View after 12 months of exposure to the  
local environmental conditions

Application was carried out in accordance with Belzona Know-How System Leaflets RPA-9, RPA-10 & RPA-11. Spalled concrete was rebuilt with Belzona 4111 before weatherproofing area with Belzona 3111 system.
