# BELZONA REPAIRS RUBBER LINED VALVES

ID: 6056

20" and 36" Gate Valves

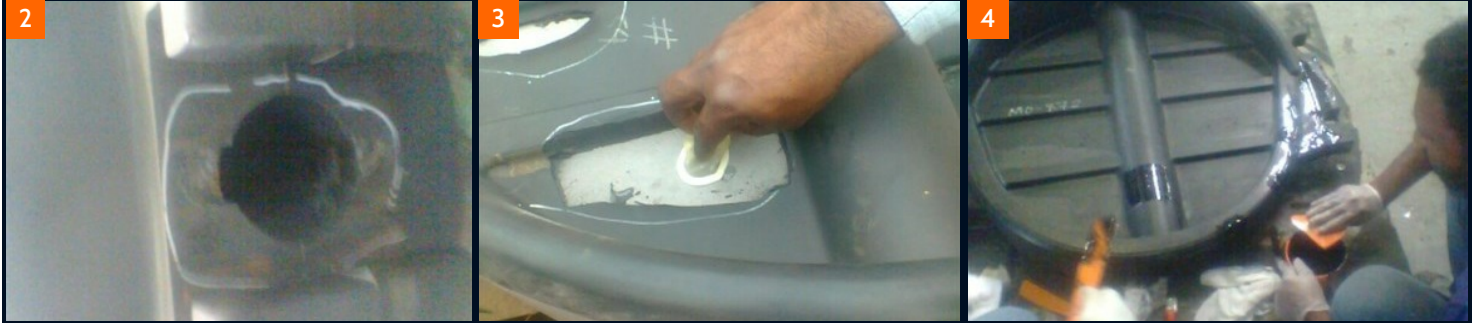
## PHOTOS

Damage to the existing rubber lining had resulted in corrosion damage to the exposed steel substrate.

1. View of existing lining damage
2. Another area of lining damage
3. Surface preparation including Chloride Test for salt contamination
4. Completed application

Application was carried out in accordance with Belzona Know-How System Leaflet VPF-3. Areas of damaged rubber lining were cut away and the exposed steel substrate was prepared by grit blasting. Following the application of Belzona 2911, the damaged areas were rebuilt using Belzona 2111.
