# LOCALIZED BELZONA REPAIRS TO RUBBER LININGS

ID: 6060

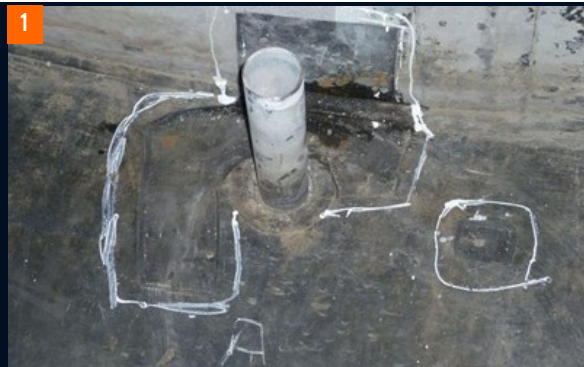
The client had recurring failures of the aged neoprene rubber linings on the site. Reinstatement or repairs with the original lining materials were impossible due to unacceptable downtime and health & safety concerns. A localised repair solution was needed that could be easily applied in confined spaces to complex surfaces, and would allow a fast return to service.

1. Defect areas marked up in a water treatment tank
2. Failed neoprene rubber lining being removed
3. Completed repairs with Belzona 2111
4. Further repairs completed on tank walls
