# PINTLE PIN AND HOUSING REBUILT WITH BELZONA

ID: 6064

Rudder pintle pin and housing on a large ship.

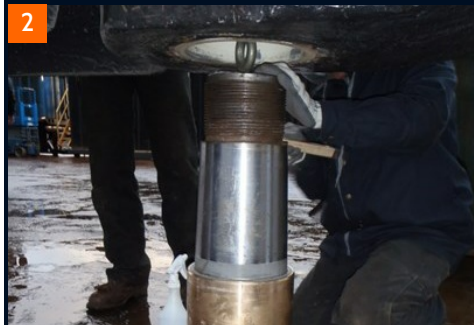
Seawater had corroded the pintle pin and housing enough so that the pin was a loose fit in the housing.

1. Pintle pin showing corrosion.
2. Pintle pin rebuilt and ready to form new housing.
3. Pintle housing showing corrosion before grit blasting.
4. Pintle housing rebuilt, ready for final assembly with Belzona 2111 sealing both ends.

The worst of the corrosion on the pin was undercut on a lathe and rebuilt with Belzona 1111. Next, the pintle housing was grit blasted and coated with Belzona 1111. The pin was coated with a release agent and lifted into the housing to form a perfect fit. The rebuilt housing was inspected and then reassembled using Belzona 2111 to seal the top and bottom of the pintle housing.
