# BELZONA COLD REPAIR TO LEAKING PIPE JOINT

ID: 6067

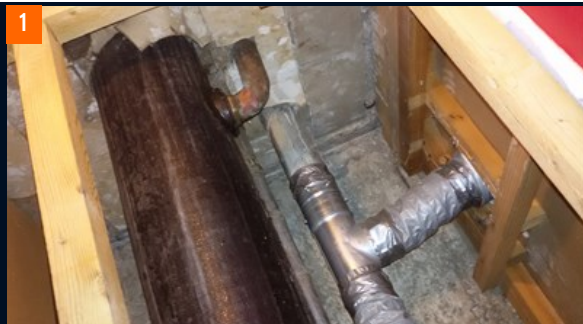
On investigation it was found that pipe was leaking at the joint and fittings were corroded.

1. Pipe/Joint location
2. Close up of corroded joint
3. Joint sealed/repaired
