# BELZONA REPAIRS LEAKING HEXANE PROCESS PIPE

ID: 6068

Customer had a through wall leak on a Hexane supply line to their manufacturing process.

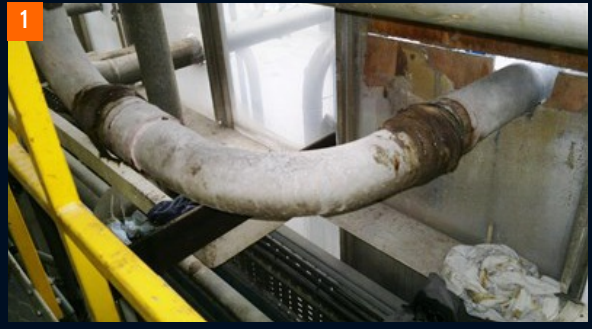
Customer had been using a temporary pipe wrap which did not offer a permanent solution. Leaking of the pipe was a Health & Safety issue due to the volatility of the Hexane product flowing through the process pipework.

1. Temporary pipe wrap
2. Removal of temporary pipe wrap
3. Permanent Belzona repair
