# BELZONA RESTORES FAN BLADES TO FINE FETTL

Blades from a Fin Fan cooler

Refinery, Scotland

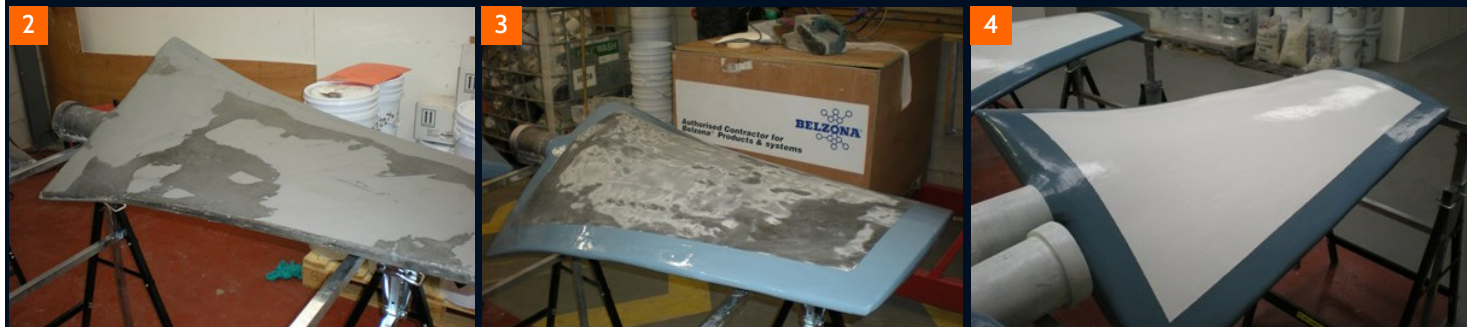
UV radiation and impingement erosion had worn down the leading edges of the fan blades, damaging the fibreglass construction.

1. The damaged fan blades
2. Damaged areas restored with Belzona 1121
3. Leading edges marked off and coated with Belzona 1341
4. Completed application

Application was carried out in accordance with Belzona Know-How System Leaflet FBC-1. The damaged areas were rebuilt and reinforced with Belzona 1121 incorporating Belzona 9341. An area of roughly 75mm around the leading edges of each fan blade were coated with Belzona 1341 to provide optimum erosion resistance. Finally the Belzona 5111 system was applied over the blades to provide UV resistance to the underlying fibreglass.
