# BELZONA REBUILDS AND PROTECTS TURBINE RUNNER

ID: 6071

Hydroelectric Plant, Jokkmokk, Sweden

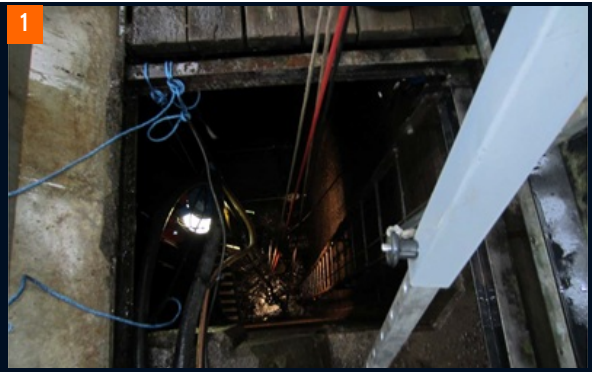
Two impeller runner blades had suffered severe cavitation and erosion damage.

1. Turbine housing entrance
2. Cavitation damage to the runner
3. Close-up of the damage
4. Completed application

Application was carried out in accordance with Belzona Know-How System Leaflets CEP-1 and CEP-3. Surfaces were grit blasted prior to rebuilding with Belzona 1311 to restore profiles and coating with Belzona 1321 to provide long-term protection.
