# BELZONA TAKES THE HEAT IN EXCHANGERS

ID: 6072

Brine Heat Exchanger

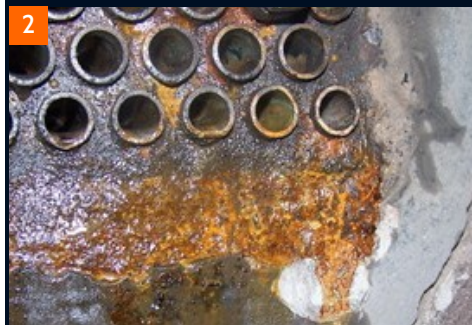
The brine heat exchangers operate at up to 138°C and are prone to rapid corrosion. The water box, separator channels and tube face had all suffered extreme corrosion and the separator plate was being bypassed.

1. Condition 1 year after previous coating was applied.
2. Damage and failure close up.
3. Tube face separator channels rebuilt.
4. Protected heat exchanger being reassembled.

The customer had tried several materials previously on these heat exchangers and because of the severely corrosive and elevated temperature service conditions, none had lasted more than a year or two. Belzona 1593 is designed for permanent immersion conditions up to 160°C and so it was the ideal coating to protect all parts of this asset.
