# BELZONA TERMINATES ATTACK FROM CHILLER TREATMENT CHEMICALS

ID: 6073

Lower tanks of chiller units suffering attack from Legionella treatment chemicals.

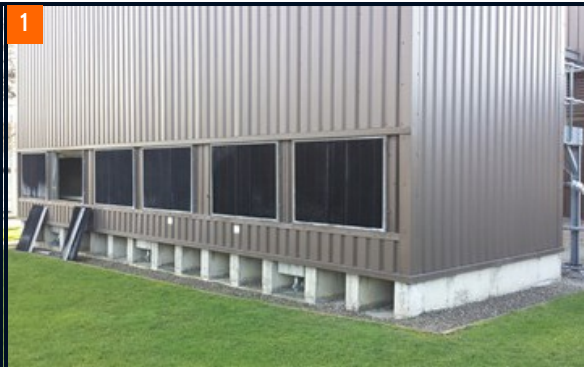
1. Chiller units
2. Lower tanks during initial inspection in 2014
3. Condition of tanks close-up before coating
4. Tanks protected with Belzona 5811 in 2014

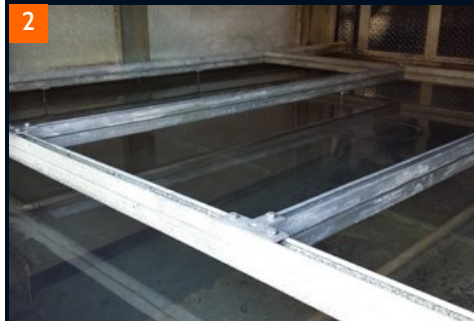
The galvanised steel and carbon steel surfaces of these tanks were being attacked by the chemicals that were being used to keep Legionnaires' disease in check and from corrosion. It was understood that without action, the tanks would start to leak and so all six tanks were to be coated in phases.
