# HEAT EXCHANGER RELIABLY REFURBISHED WITH BELZONA

ID: 6074

Straight Tube Heat Exchanger

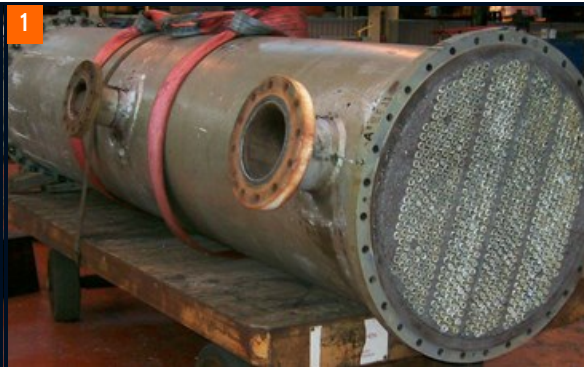
1. Heat exchanger arriving in workshop
2. Pitting damage clearly visible after grit blasting
3. Tube face being rebuilt
4. Belzona application completed

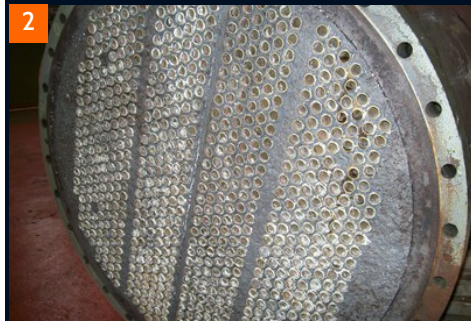
This Propylene heat exchanger operates at up to 120°C and the tube face had suffered severe galvanic and pitting corrosion. The separator channels and tube face had to be completely rebuilt to prevent bypass of the separator plate. In addition, the client required a lining to prevent further attack to the water boxes, nozzles and the tube faces.
