# BELZONA SEALS LEAKING HEAT EXCHANGER PIPE

ID: 6075

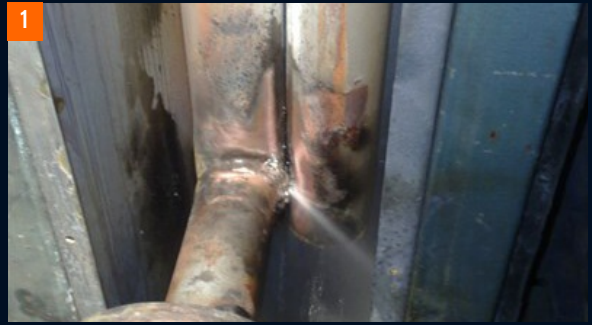
Customer had made several attempts to braze the leak without success due to the thin wall nature of the copper pipework. The nature of the continuous leak was creating a safety hazard.

Pin hole leak on T Junction of the heat exchanger pipework.

1. Leaking pipework
2. Pipework manually prepared
3. Pipework repaired
