# BELZONA STOPS COSTS SPIRALLING OUT OF CONTROL

ID: 6076

Spiral Heat Exchangers commonly used within part of the client's facilities.

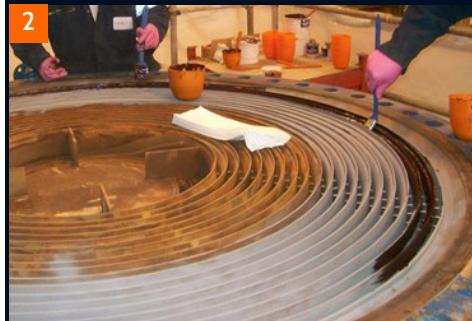
An unwanted reaction within these assets is the formation of hot hydrochloric acid, which was then attacking the steel spirals. It was thought that there were only a few weeks left before the heat exchanger would fail. The lead time on a replacement was nearly 12 months.

1. One end of spiral heat exchanger untreated
2. Belzona 4311 application underway
3. Close up of coating
4. Completed application

The steel was grit blasted, followed by a brush application of 3 coats of Belzona 4311 in accordance with Belzona Know-How System Leaflet TCC-5.

The replacement cost for this heat exchanger was over £230,000. Belzona was used to coat the affected areas on both ends of the asset with a material that can withstand hydrochloric acid, even at 60°C. The whole application was completed with only minor material costs of about £600. The client then repeated the application on a further two identical spiral heat exchangers the following year.
