# BELZONA RESTORES AND PROTECTS CORRODED PIPEWORK

ID: 6077

Steel plant, Czech Republic

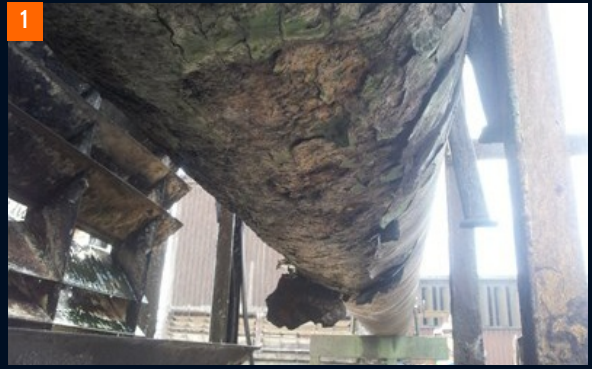
The lower part of the outer casing of the cooling circuit pipe was heavily corroded, causing a weakening of the actual mantle and localised coolant leak.

1. Corroded pipework
2. Belzona 1111 and reinforcing metal plates applied
3. Pipeline coated with Belzona 5811 incorporating Belzona 9341

Application was carried out in accordance with Belzona Know-How System Leaflets VPF-2 and VPF-11. After surface preparation, the badly corroded areas were repaired with Belzona 1111 and reinforcing metal plates. The pipeline was then treated with the Belzona 5831 and Belzona 5811 incorporating Belzona 9341 to provide long term corrosion protection.
