# BELZONA TACKLES AN EXPLOSIVE SITUATION

ID: 6078

The gas supply line for a blast furnace

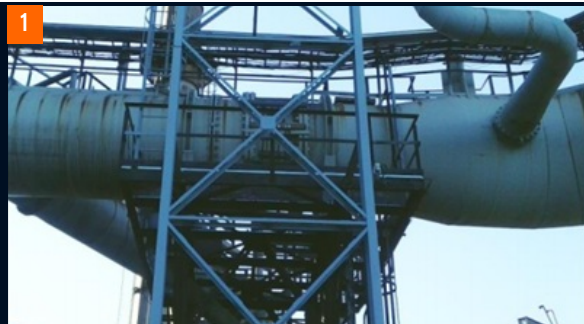
Pipeline had developed a crack which was leaking gas into the atmosphere. The repair had to be performed live. The intake pipe had a diameter of 2,000mm and had developed a crack 2,500mm long and 2mm wide.

1. The damaged pipework
2. Applying the first seal of Belzona 1211
3. Main layer of Belzona 1111 and sheet applied
4. Completed application
