# BELZONA SAVES OIL COOLER FROM SCRAP HEAP

ID: 608

Oil cooler in power station

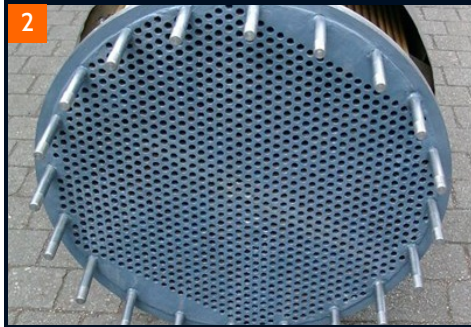
After 40 years in service the oil coolers were suffering from severe corrosion.

1. Corroded tubesheet
2. Completed tubesheet
3. Tubesheet at opposite end
4. Close-up

The corrosion damage was rebuilt with Belzona® 1311 and coated with Belzona® 1321 in accordance with Belzona System Leaflets HEX-1 and HEX-3.
