# BELZONA UPGRADES BASEMENT TO PLANT ROOM USE

ID: 6086

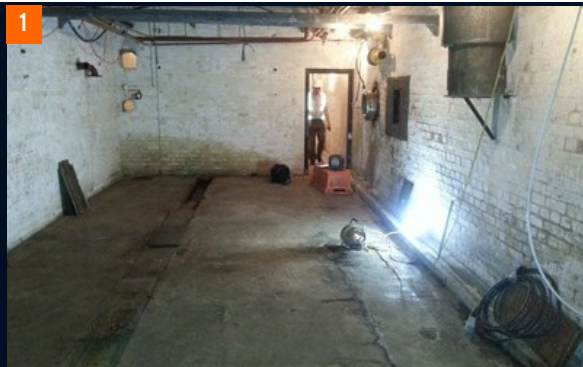
The existing concrete floor had many broken and damaged areas and the steep steps down into the basement were smooth and slippery

1. Disused basement before
2. Belzona 4111 and 4131 being installed to repair floor
3. Completed plant room with floor coated with Belzona 5231
